## Home Inspection Report

Inspected By: Henry L Crawford

Inspected On Tue, Apr 28, 2026 at 9:30 AM

**Crawford & Associates Inspections**  
(205) 288-7338  
<https://www.crawfordhomeinspections.info>  
[Crawford.homeinspections@gmail.com](mailto:Crawford.homeinspections@gmail.com)

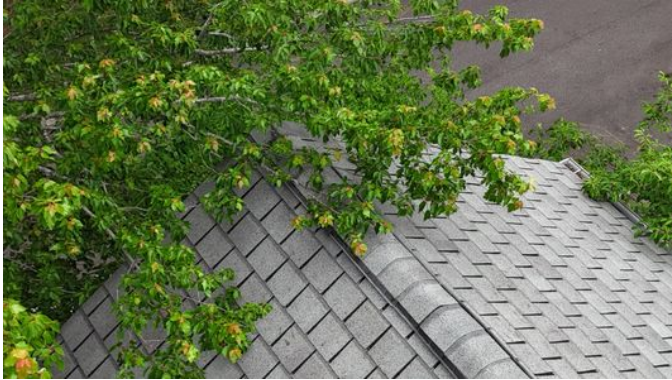
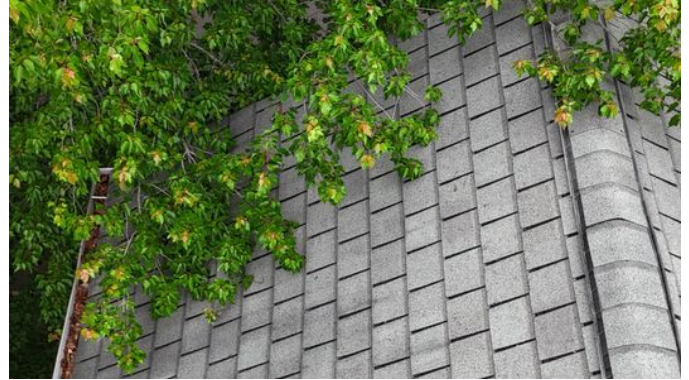
Growing Against Structure

Recommend trimming back vegetation to maintain proper clearance from the structure and roof surfaces. Seasonal pruning should be performed as part of an ongoing landscape maintenance plan.

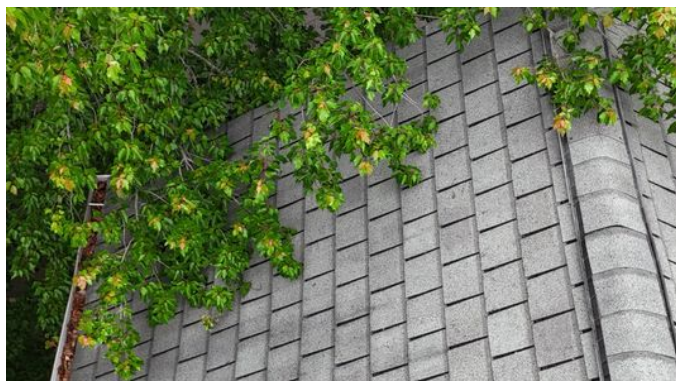
Implication: Contact with tree limbs can damage shingles, accelerate wear, and create pathways for moisture intrusion. Overhanging branches can also deposit debris into gutters, increasing the risk of clogs and improper roof drainage.

Recommendation: Recommend trimming tree limbs back from the roof covering by a qualified tree service contractor prior to closing or as part of ongoing maintenance.

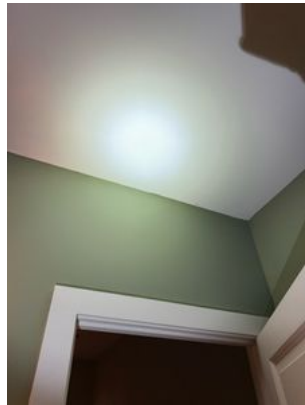
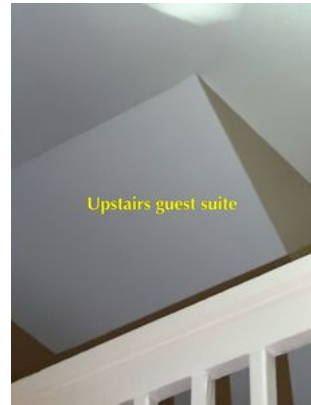
Implication: Contemporary residential safety standards recommend smoke detectors in each sleeping area and adjacent hallways to provide early warning in the event of a fire. Smoke detectors beyond their typical 10-year lifespan may not function reliably, reducing overall fire safety.

Recommendation: Recommend installation of additional smoke detectors to provide proper coverage of all sleeping areas and adjoining hallways. Also recommend replacing the aged smoke detector in the garage with a new, 10-year sealed lithium battery unit or other approved device. Improvements should be completed prior to closing to enhance occupant safety.

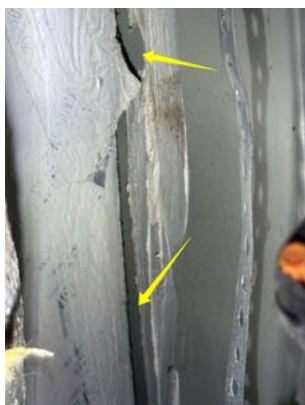
Implication: Unsealed duct connections can allow unconditioned, contaminated crawlspace air to enter the living space, potentially affecting indoor air quality, system efficiency, and occupant comfort. Moisture and debris within HVAC components may further contribute to microbial growth, odors, and reduced system performance if not addressed.

Recommendation: Recommend further evaluation, sealing of duct connections, and professional cleaning of affected HVAC components by a licensed HVAC contractor. Corrections should be completed prior to closing to improve air quality, system efficiency, and proper operation.

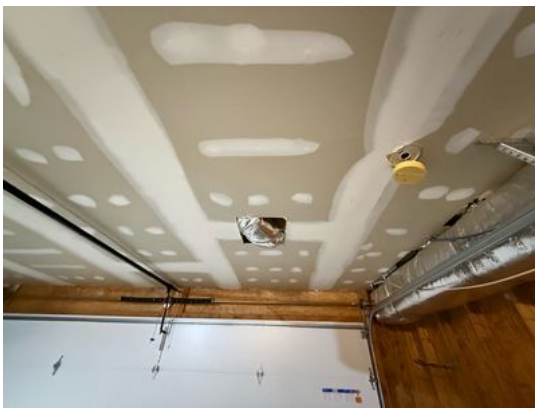
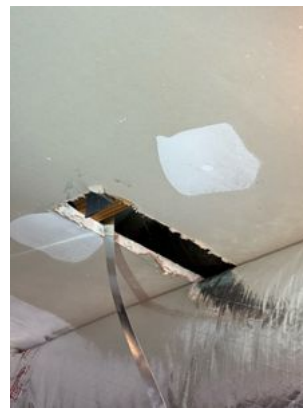
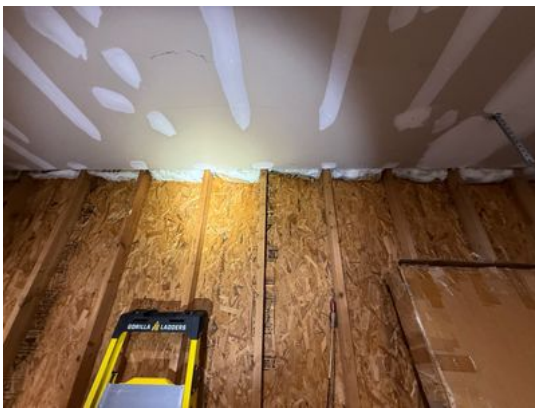
Openings and breaches were noted in the garage ceiling drywall beneath finished living space, which may compromise the intended fire-resistive separation between the garage and the habitable area above. This condition may allow the passage of smoke, fire, or gases through the assembly and does not appear consistent with current residential standards.

Recommendation: Recommend further evaluation by a qualified drywall contractor to determine needed repairs and provide completion/repair cost estimates prior to closing. Corrections should include proper repair and sealing of penetrations as needed to help restore the intended fire separation.

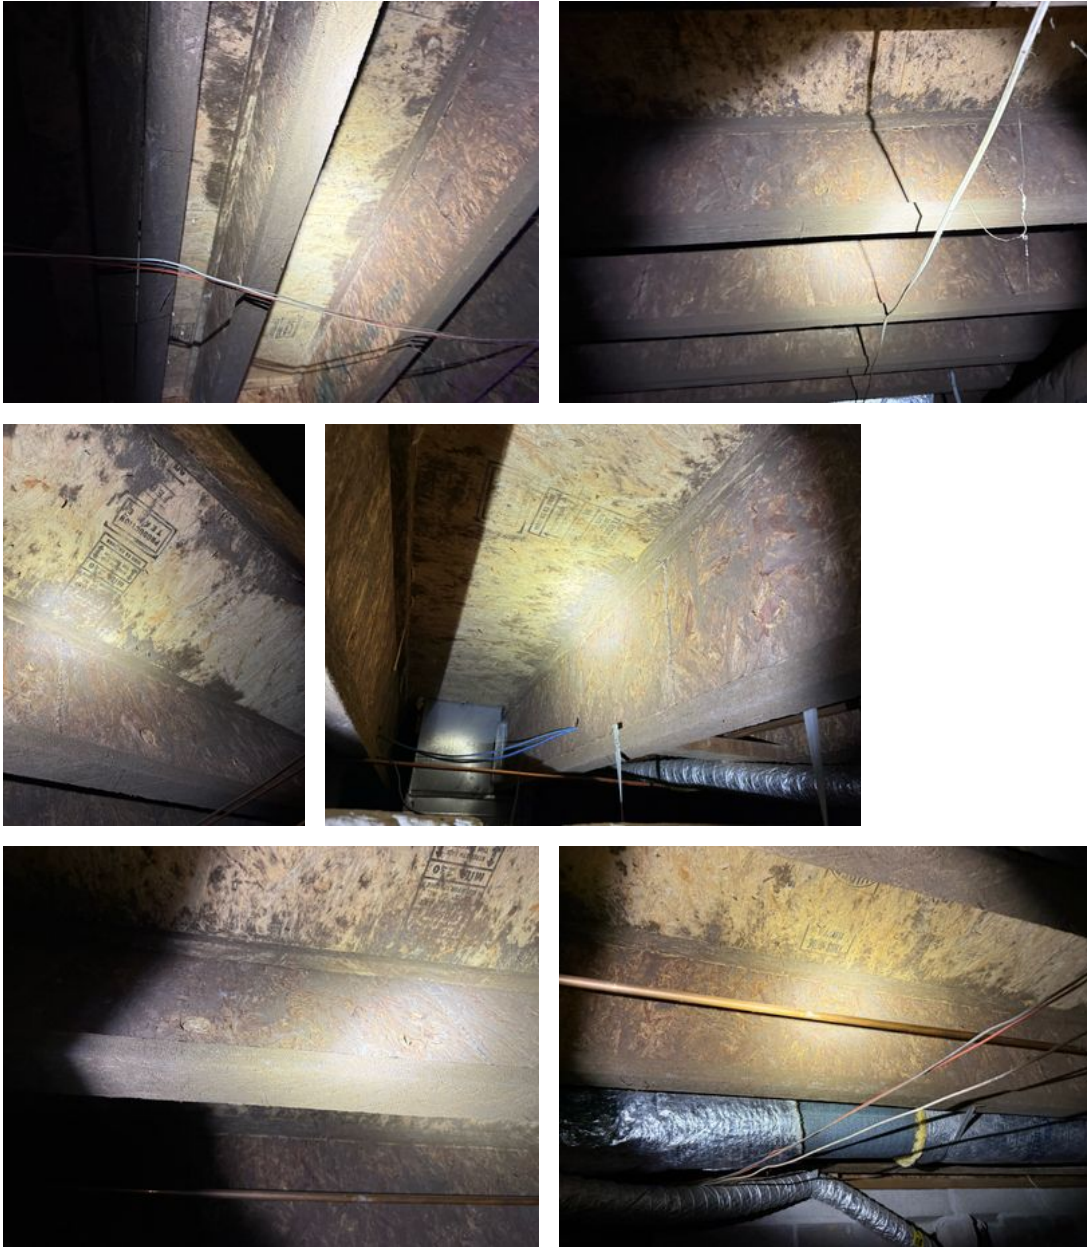
Implication: Microbial growth may be associated with prior moisture exposure, can contribute to material deterioration over time, and may affect interior air quality.

Recommendation: Recommend further evaluation and remediation, as needed, by a qualified contractor, along with exploration of moisture control improvements, including possible crawlspace encapsulation options if preferred, prior to closing and occupancy.
