## Home Inspection Report

Inspected By: Henry L Crawford

Inspected On Tue, Apr 28, 2026 at 9:30 AM

**Crawford & Associates Inspections**  
(205) 288-7338  
<https://www.crawfordhomeinspections.info>  
[Crawford.homeinspections@gmail.com](mailto:Crawford.homeinspections@gmail.com)

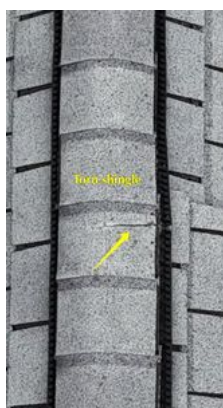
Observation: Damaged, cracking and torn ridge shingles were noted at the time of inspection.

Explanation: Portions of the roof covering showed physical deterioration and loss of integrity.

Implication: Damaged shingles can increase susceptibility to wind damage and water intrusion.

Recommendation: Recommend further evaluation by a qualified roofing contractor to determine repair or replacement options and associated costs prior to closing.

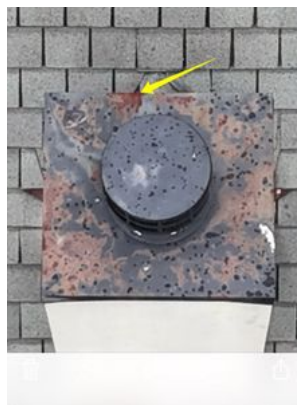
#### Comment 6

Chimney Caps – Rust / Corrosion Observed

Both chimney caps displayed significant rust and corrosion at the time of the inspection.

Advanced corrosion can lead to thinning metal and eventual pinhole development. This condition may allow moisture intrusion into the chimney flue system, contributing to deterioration of masonry components, flue liners, and interior finishes over time.

Recommend further evaluation by a qualified chimney contractor to determine whether cleaning and application of rust-inhibitive coating is appropriate. Corrections are recommended prior to closing to help prevent continued metal cap damage.

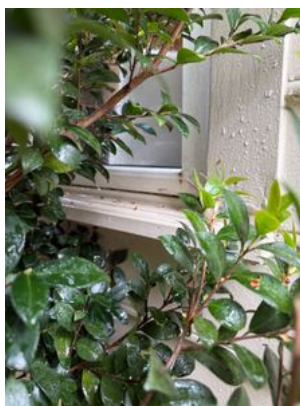
Exterior – Gutters (Debris / Leakage Concerns-above kitchen picture window)

Gutters on the right rear of the home, and garage, were observed to be holding debris, and appeared to spill over when rain was falling.

Debris buildup and leaking can prevent proper water drainage, leading to overflow and potential siding/moisture intrusion at the foundation, siding components, windows or adjacent structural components.

Recommend cleaning the gutters by a qualified contractor to ensure proper function. Improvements should be considered prior to closing or as part of an ongoing home maintenance plan.

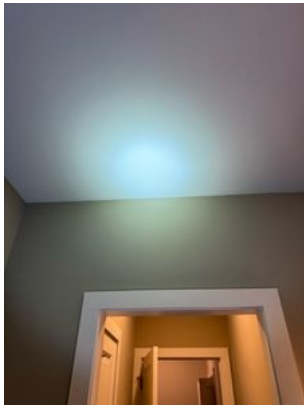
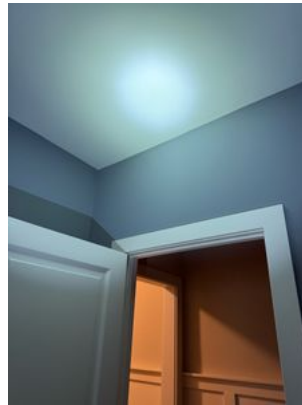
Smoke Detectors – Insufficient Coverage & Aged Unit Noted (main house)

Defect / Observation: An insufficient number of smoke detectors were observed in or near the sleeping areas of the home. Additionally, the smoke detector located in the garage appeared to have surpassed its expected service life.

Implication: Contemporary residential safety standards recommend smoke detectors in each sleeping area and adjacent hallways to provide early warning in the event of a fire. Smoke detectors beyond their typical 10-year lifespan may not function reliably, reducing overall fire safety.

Recommendation: Recommend installation of additional smoke detectors to provide proper coverage of all sleeping areas and adjoining hallways. Also recommend replacing the aged smoke detector in the garage with a new, 10-year sealed lithium battery unit or other approved device. Improvements should be completed prior to closing to enhance occupant safety.

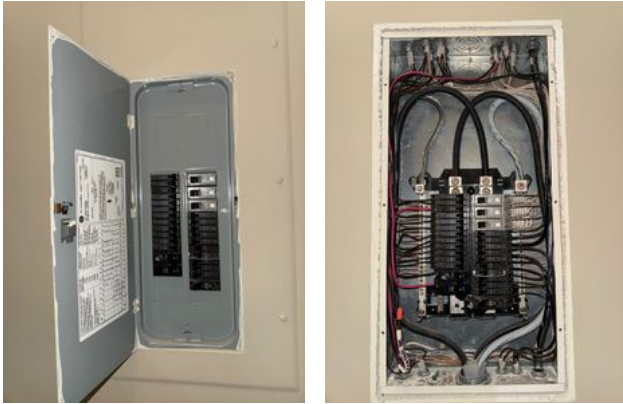
### Comment 11 Information

Observation: The subpanel in the garage was restricted from inspection due to stored items and appliances.

Explanation: Access limitations prevented full visibility and evaluation of all panel components and conditions.

Implication: Conditions or defects may exist within concealed or obstructed areas that were not observable at the time of inspection.

Recommendation: Recommend further evaluation of the panel condition by a licensed electrical contractor prior to closing.

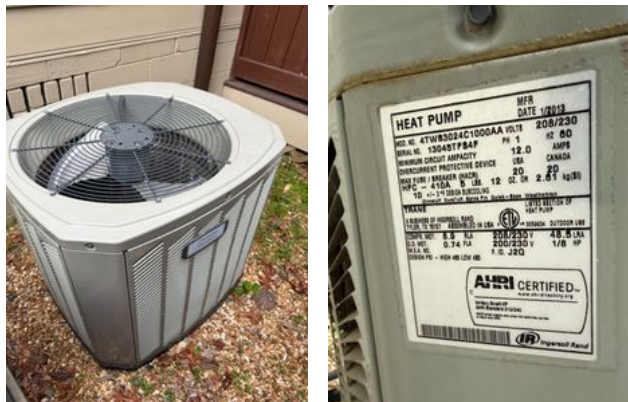
Due to age, the system should be considered an older unit. While replacement is not implied solely based on age, increased potential for repairs, efficiency decline, or refrigerant-related service should be anticipated over time.

Because the unit is over 7 years old, a full professional HVAC service and cleaning is recommended prior to closing. Routine maintenance helps support efficiency, reliability, and may help extend remaining service life.

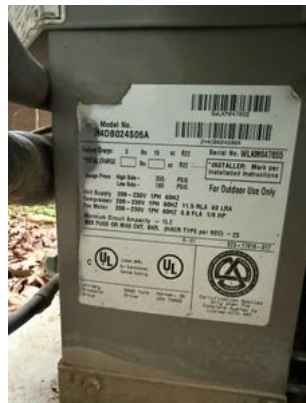
Typical service life for an air conditioning condensing unit is approximately 12–18 years. At approximately 21 years old, this unit is beyond typical expected service life.

This system uses R-22 refrigerant, an older refrigerant that has been phased out, which can make major repairs involving refrigerant or compressor replacement increasingly costly.

Due to age and refrigerant type, the unit should be considered at or beyond the end of its typical service life. A full professional HVAC evaluation and service is recommended prior to closing, and budgeting for repair or replacement in the near term would be prudent.

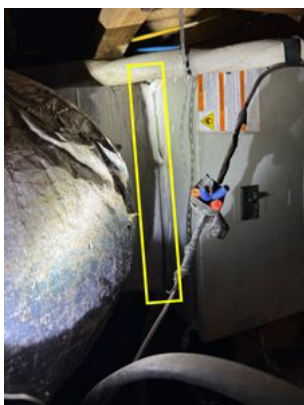
**Comment 20**  
**Repair Item**

HVAC Ductwork – Air Leakage Noted

Defect / Observation: A conditioned air leak was observed at the HVAC ductwork connection in the crawlspace.

Implication: Unsealed duct connections can allow unconditioned, contaminated crawlspace air to enter the living space, potentially affecting indoor air quality, system efficiency, and occupant comfort. Moisture and debris within HVAC components may further contribute to microbial growth, odors, and reduced system performance if not addressed.

Recommendation: Recommend further evaluation, sealing of duct connections, and professional cleaning of affected HVAC components by a licensed HVAC contractor. Corrections should be completed prior to closing to improve air quality, system efficiency, and proper operation.

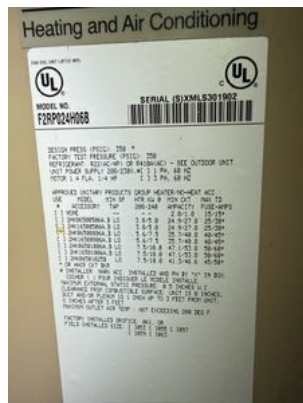
## Air Handler/Furnace 3

Because the indoor unit is older, attention should be given to evaporator coil condition, blower motor wear, drain management, and compatibility/match with the outdoor condenser. If paired with an R-22 system, future repair costs may be elevated.

Due to age, a full professional HVAC evaluation and service is recommended prior to closing. Budgeting for repair or replacement in the near term would be prudent.

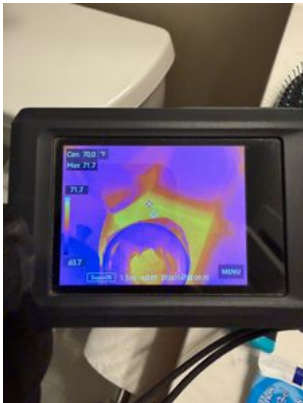
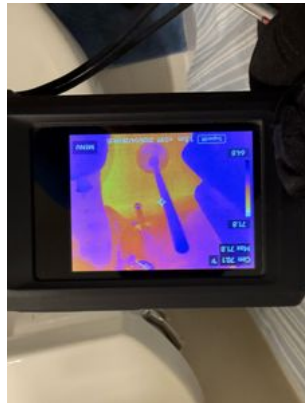
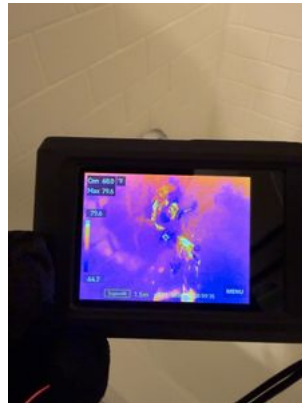
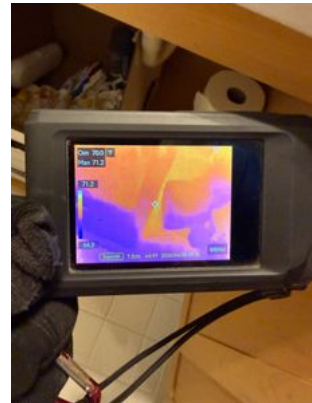
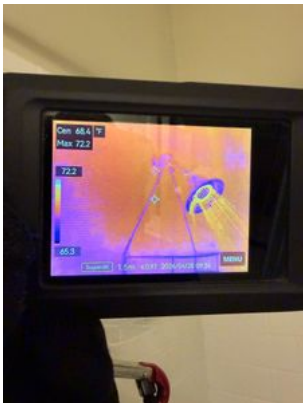
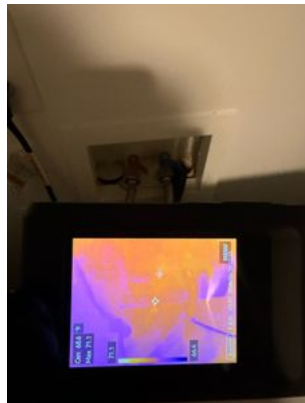
Thermal imaging did not confirm the presence of active leaks at the time of inspection around plumbing fixtures and other observed wet areas. It is important to note that thermal imaging provides only a snapshot in time. Hidden leaks, slow leaks, or intermittent leaks may not be detected during the inspection.

Recommend ongoing monitoring of these areas and consulting a licensed plumbing contractor if signs of moisture develop in the future.

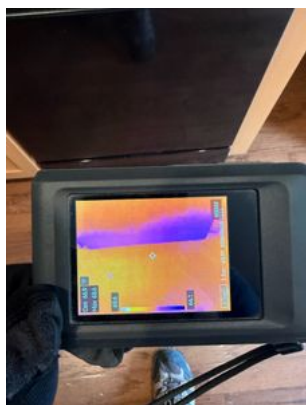
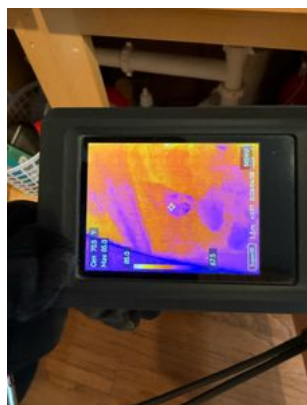
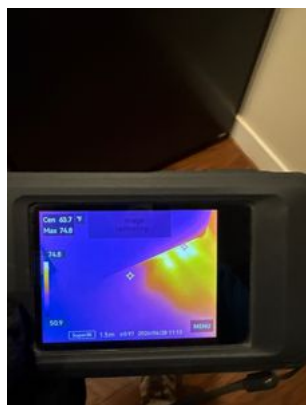
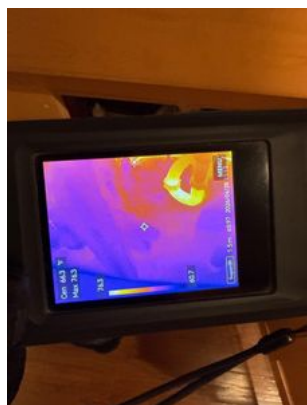
Thermal images from guest suite

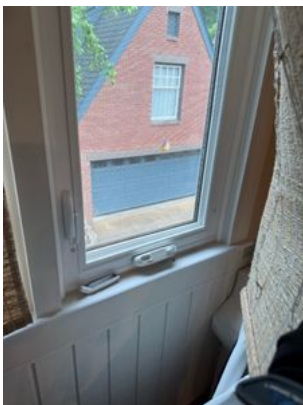
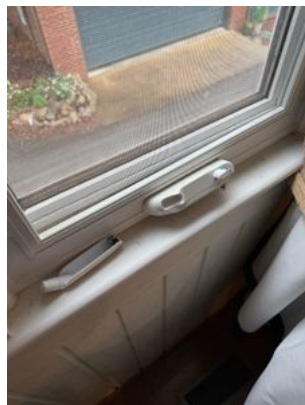
The window was damaged/not operating handles or hardware. Missing hardware can limit operability, compromise security, and reduce ease of use.

Recommend installation of appropriate replacement hardware by a qualified contractor to restore proper function.

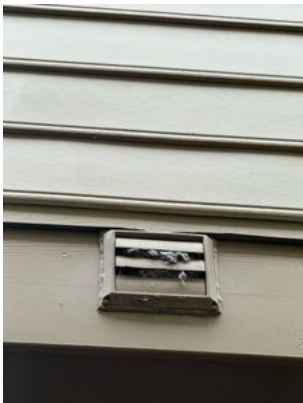
Observation: Significant lint buildup was observed at the dryer vent.

Implication: Restricted airflow can reduce dryer performance and represents a potential fire hazard if not corrected.

Recommendation: Recommend professional cleaning and further evaluation of the dryer vent system by a qualified contractor prior to closing, along with periodic maintenance thereafter to help ensure safe operation.

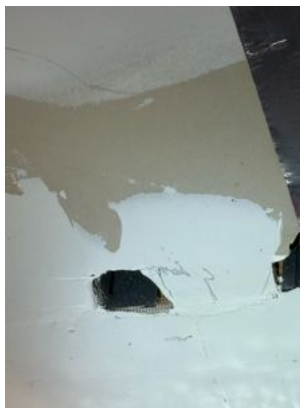
##### Garage Fire Separation – Incomplete/Damaged Drywall

Openings and breaches were noted in the garage ceiling drywall beneath finished living space, which may compromise the intended fire-resistive separation between the garage and the habitable area above. This condition may allow the passage of smoke, fire, or gases through the assembly and does not appear consistent with current residential standards.

Recommendation: Recommend further evaluation by a qualified drywall contractor to determine needed repairs and provide completion/repair cost estimates prior to closing. Corrections should include proper repair and sealing of penetrations as needed to help restore the intended fire separation.

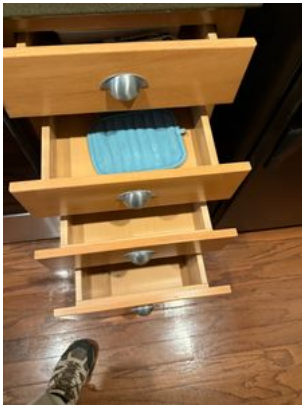
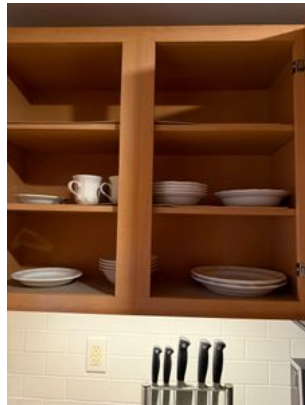
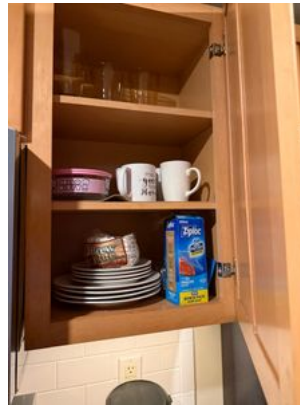
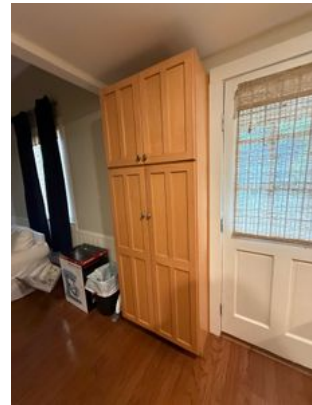
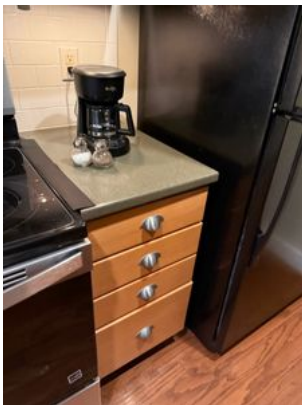
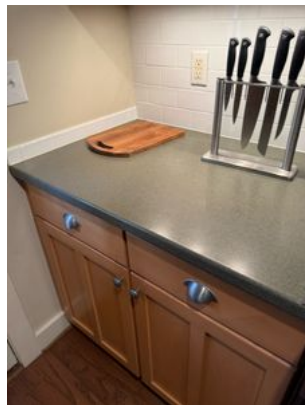
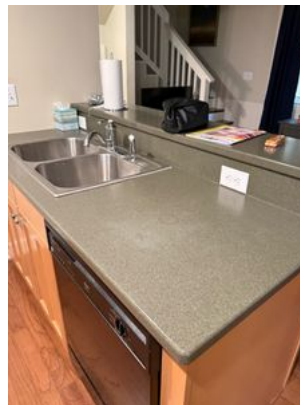
**Comment 40**  
**Information**

Garage suite cabinets

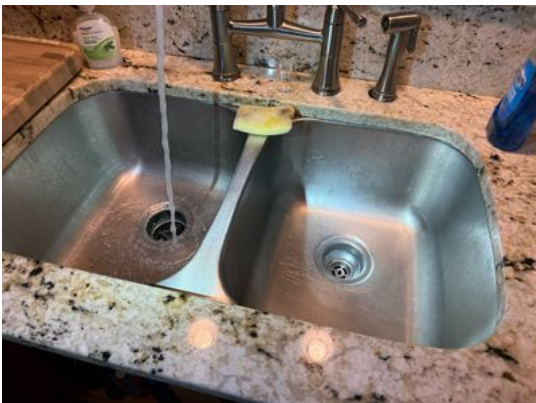
### Comment 41 Information

The kitchen sink disposal was smoothly operational as desired.

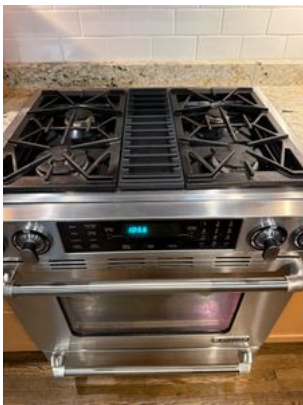
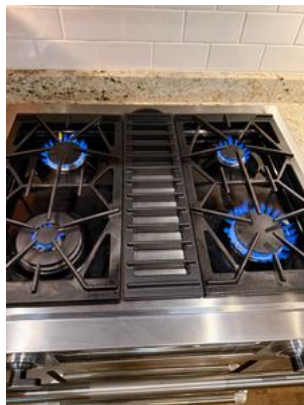
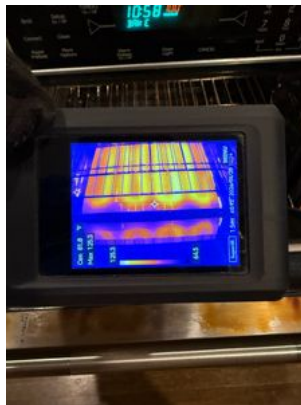
#### Comment 42

Observation: A suspected improper flame diverter was noted at the front left burner of the gas range.

Explanation: The burner component appeared improperly configured or positioned, which may be affecting normal flame distribution and burner performance.

Implication: Improper burner performance can affect cooking function and may indicate a component issue requiring correction.

Recommendation: Recommend further evaluation and repair by a qualified appliance technician prior to closing.
